## EARLY SAFETY ALERT No: 01/2018

### Non Authentic Test Certificate for mooring rope

<b>Accident by which this Safety Early Alert was induced:</b>	Parting of a ship's mooring line and death of one crew member.
<b>Safety Early Alert addressed to:</b>	All parties related to the supply and survey process of marine equipment.
<b>Date of publication:</b>	17/07/2018

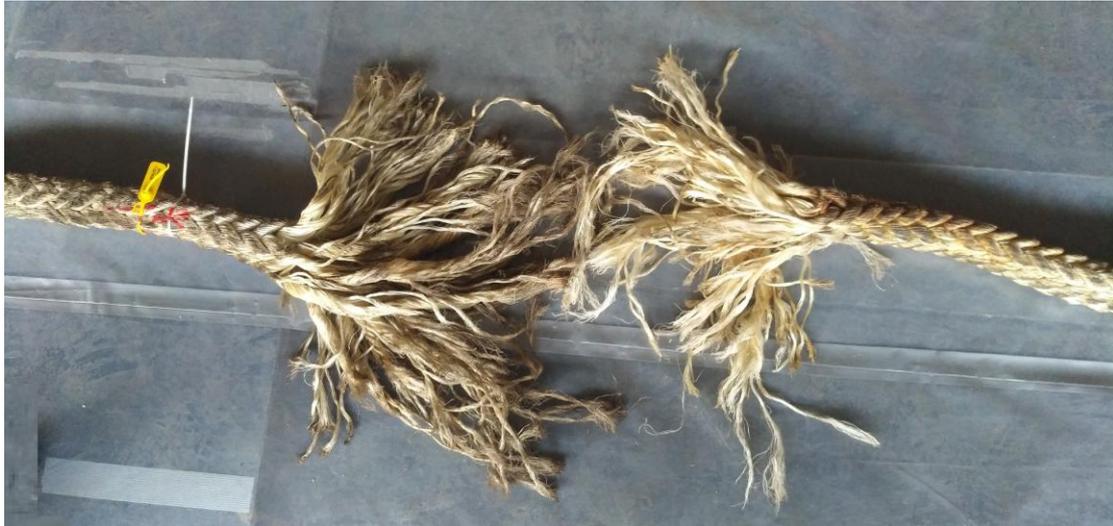
During the casualty, a mooring line of a ship parted. The breakage areas on both of the parts after the casualty are displayed in Figure no 1.

In addition to the above, the parted mooring line was not permanently marked in order its positive identification to be feasible.

**Figure no 1:** Both parts of the mooring line after its breakage.

Moreover, HBMCI **strongly recommends** to all parties related to the supply and survey process of marine equipment, and especially of critical safety equipment components, **to verify the authenticity of documentation** certifying the characteristics of such equipment, **by communicating directly with the issuing organization written on them.**
