EARLY SAFETY ALERT No: 01/2018

Non Authentic Test Certificate for mooring rope

Accident by which this Safety Early Alert was induced:	Parting of a ship's mooring line and death of one crew member.
Safety Early Alert addressed to:	All parties related to the supply and survey process of marine equipment.
Date of publication:	17/07/2018

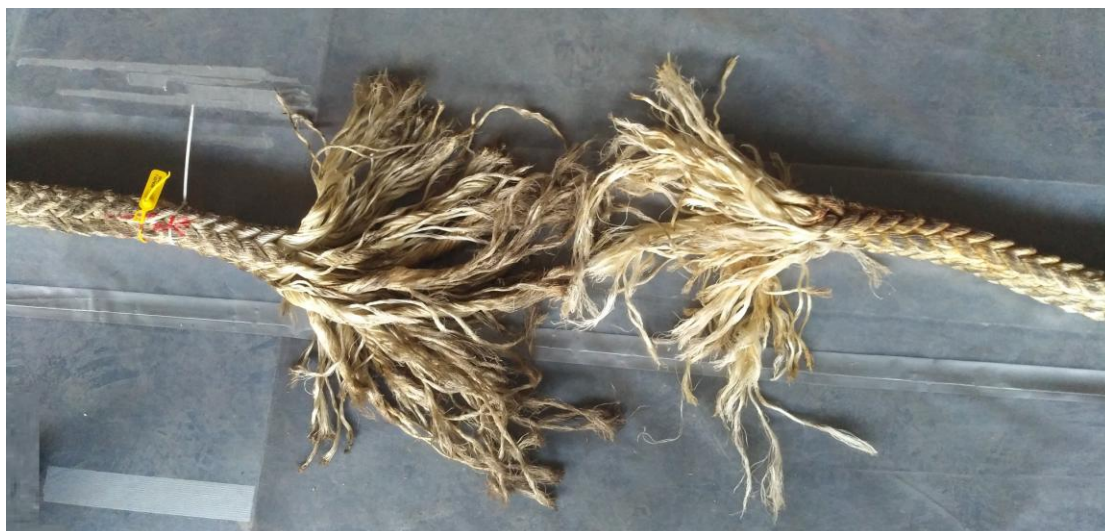
During the casualty, a mooring line of a ship parted. The breakage areas on both of the parts after the casualty are displayed in Figure no 1.

Figure no 1: Both parts of the mooring line after its breakage.
